Inspection & Structural Repairs in Cement Kiln Baghouse – Restores Operating & Environmental Performance

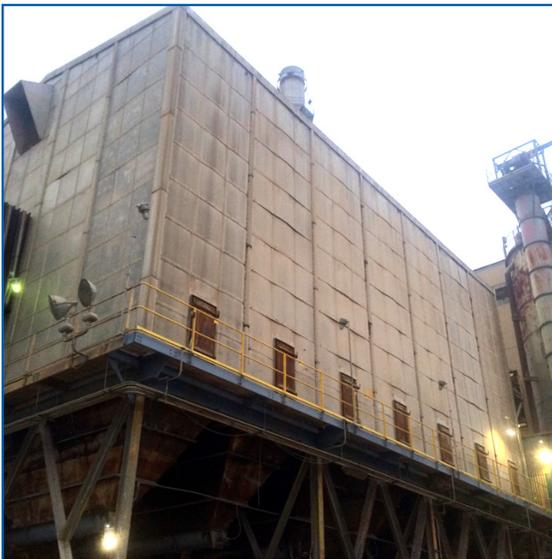
Reverse-Air Kiln Baghouse

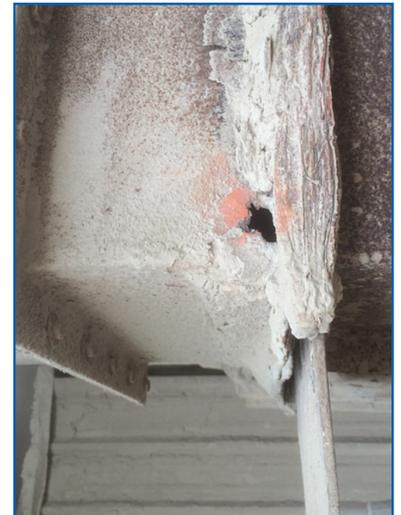
Our complete inspection revealed structural integrity issues. Broken expansion joints and ductwork defects were found after the baghouse, but before the outlet stack. These structural issues were the point of entry for fugitive dust being registered at the stack emission monitor. Fugitive dust is an environmental air quality term for very small particles suspended in the air, primarily mineral dust.

Expansion Joint Leakage

After our team identified the structural integrity issues in this kiln baghouse, we made the necessary structural repairs and desirable baghouse performance was restored, including the avoidance of penalties from non-compliance.
