# Cement Industry

## Inspection & Structural Repairs in Cement Kiln Baghouse - Restores Operating & Environmental Performance

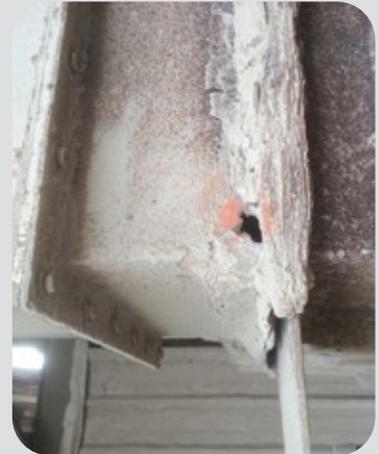
Our complete inspection revealed structural integrity issues. Broken expansion joints and ductwork defects were found after the baghouse, but before the outlet stack. These structural issues were the point of entry for fugitive dust being registered at the stack emission monitor. Fugitive dust is an environmental air quality term for very small particles suspended in the air, primarily mineral dust.

Expansion Joint Leakage

After our team identified the structural integrity issues in this kiln baghouse, we made the necessary structural repairs and desirable baghouse performance was restored, including the avoidance of penalties from non-compliance.
